FST2XT Software Change History

Issued by: NEW Lift Steuerungsbau GmbH

Release: FST V0188, 06.02.2025

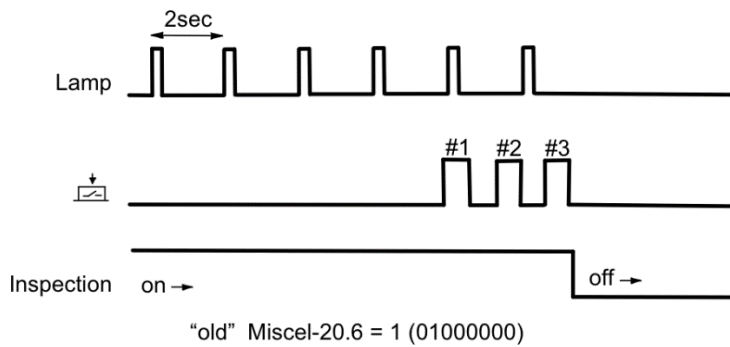
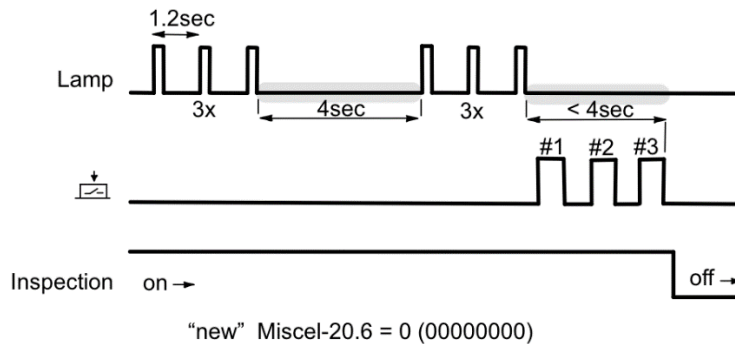
10) Pit Inspection Reset via Landing Call:

When using the bottom landing call button attached to an ADM/EAZ Module, the blink signalling pattern has been changed slightly to work with EAZ modules that cannot read the button input whilst illuminated. If required, the “old” method can be restored using Miscel-20.6
