FST2XT Software Change History

Issued by: NEW Lift Steuerungsbau GmbH

Release: FST V0183, 03.04.2024

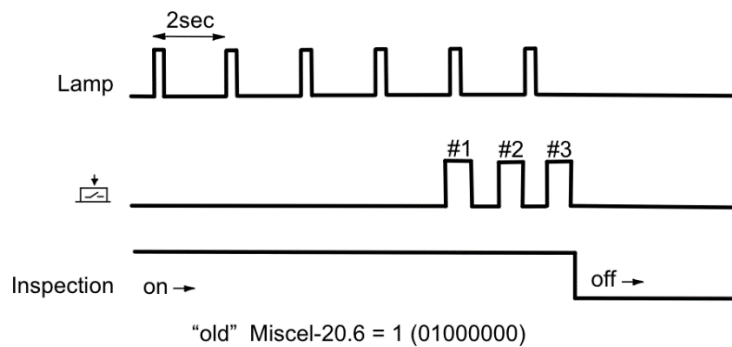
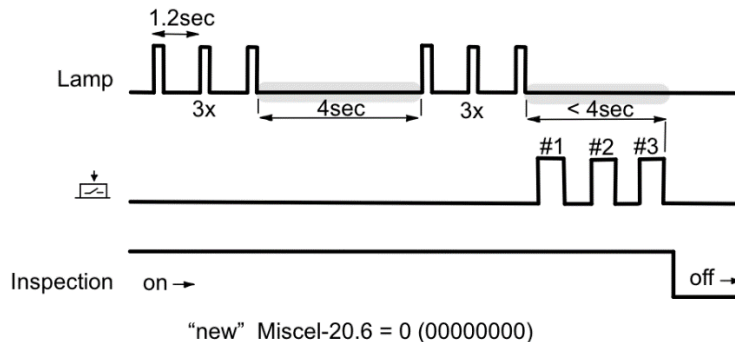
10) Pit Inspection Reset via Landing Call:

When using the bottom landing call button attached to an ADM/EAZ Module, the blink signalling pattern has been changed slightly to work with EAZ modules that cannot read the button input whilst illuminated. If required, the “old” method can be restored using Miscel-20.6
