FST2XT Software Change History

Issued by: NEW Lift Steuerungsbau GmbH

Release: FST V0156, 31.01.2020

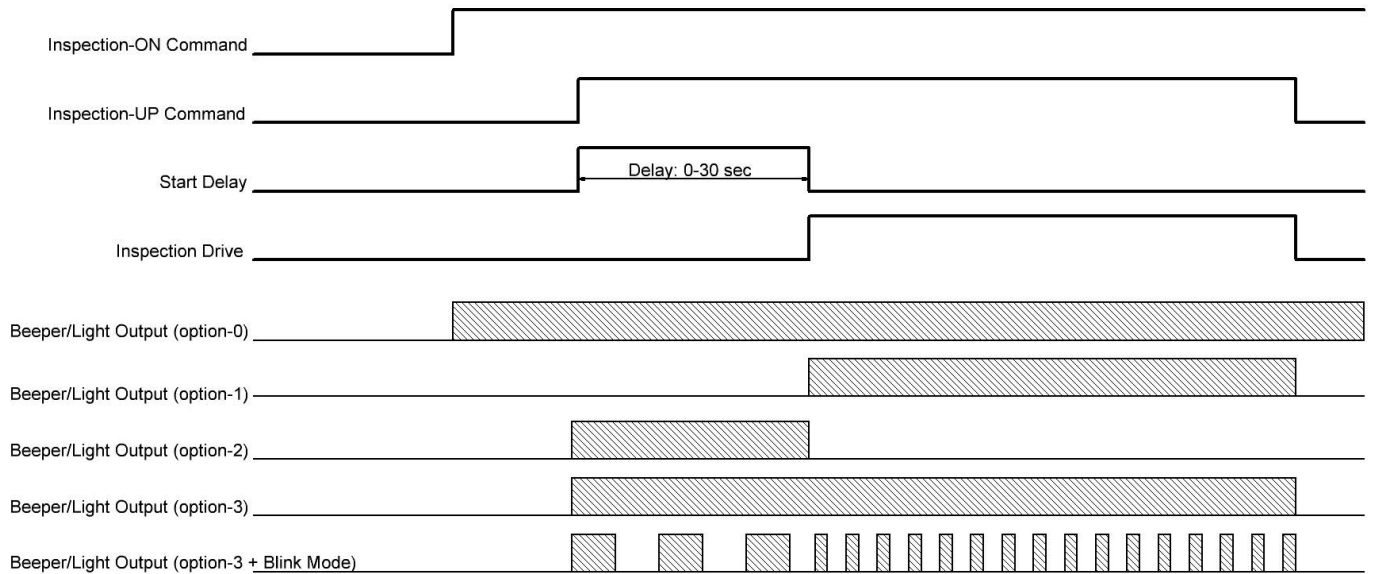
3) Inspection Start-Delay Option: new feature allows a programmable time to expire between the

user activating a inspection drive and the actual drive. This facility is available separately for Up and DOWN direction. A new Output Port is available for optical/acoustic signalling.

Menu: \ Configuration \ Inspection \ Start Delay Up = 0..30 (sec)
Menu: \ Configuration \ Inspection \ Start Delay Dn = 0..30 (sec)

The output port for lamp or beeper usage, reacts to both UP or DOWN delay periods.
